CONFIDENTIAL INSPECTION REPORT

1234 Main Street, Sunnyville, Florida 33333

11/4/2005 12:00 pm to 2:00 pm

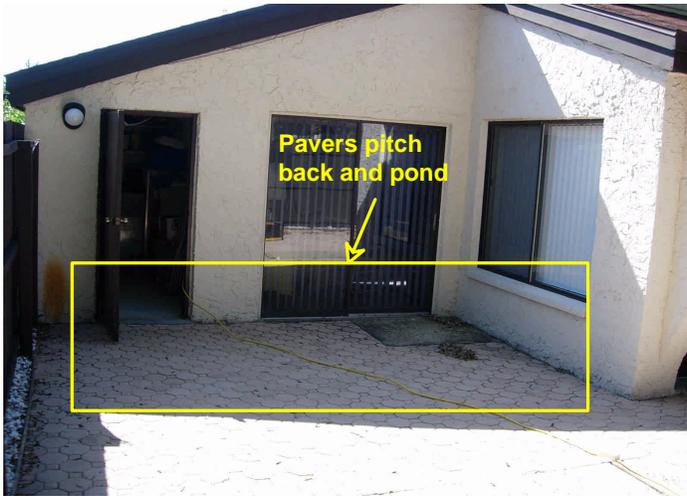
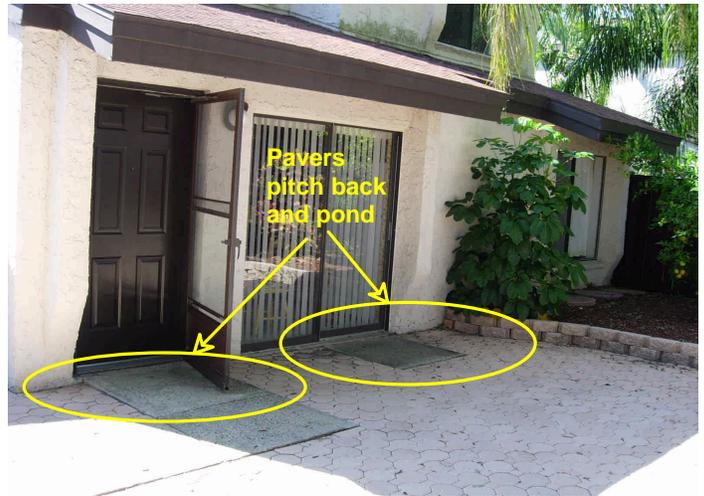
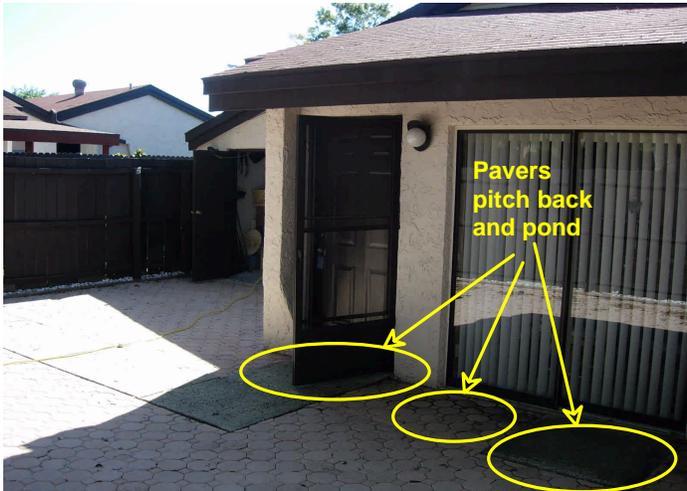
Drainage Mode

- Pavers have been installed in the courtyard area, which does not allow for rainwater to percolate into the soil. Also, the exterior elevation is close to being the same as the interior elevation and the pavers drain towards the structure instead of away, both of which create moisture problems.

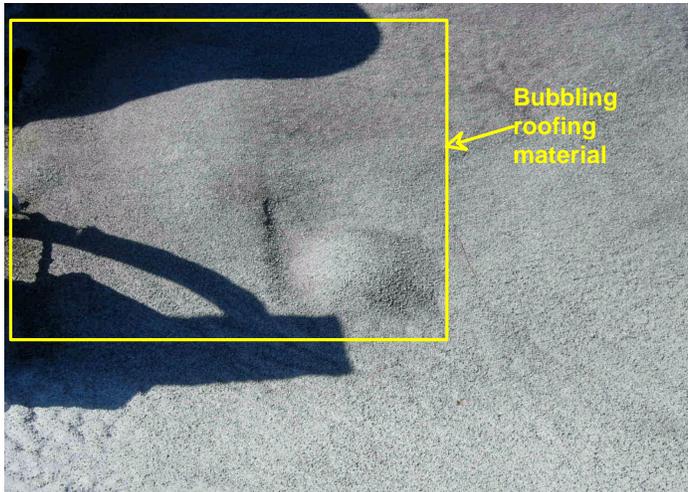
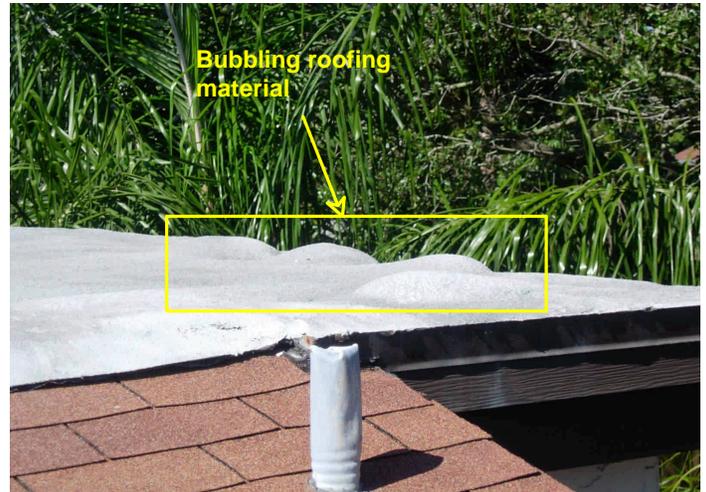
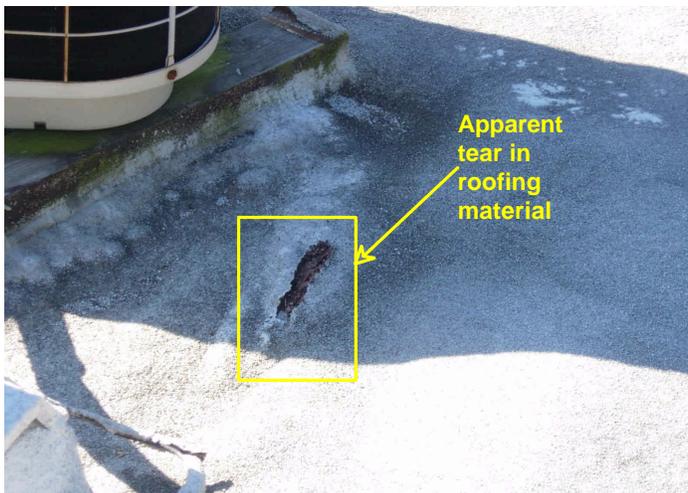
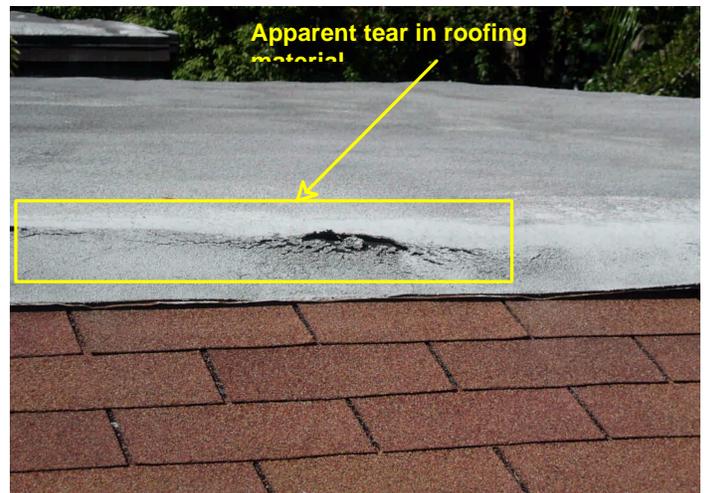
The roof appears to be insulated with a rubberized coating and there appears to be moisture in the insulation, causing the rubberized material to bubble. There also appears to be several tears in the top membrane that may allow moisture to penetrate the roof. This moisture can migrate into the living space, causing moisture problems inside the dwelling. Further investigation is warranted by a licensed roofing contractor.

We can elaborate on this issue, but it should be serviced before the close of escrow or it may leak, because our service does not include any guarantee against leaks.

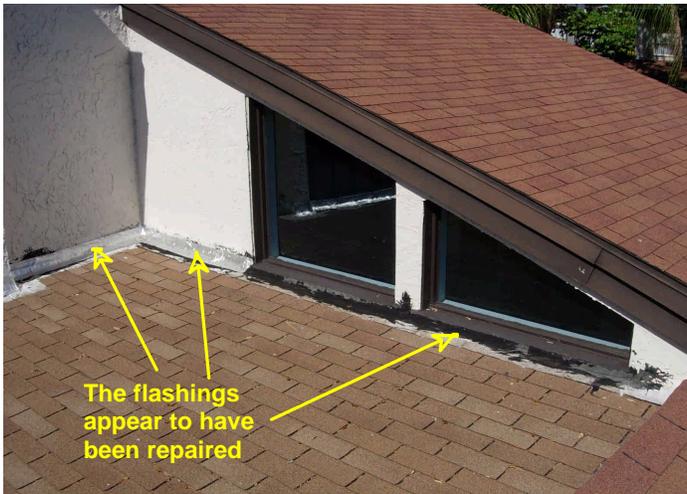
Flashings

- The flashings appear to have been repaired but the quality of the repair is undetermined. These should also be inspected by a licensed roofing contractor.

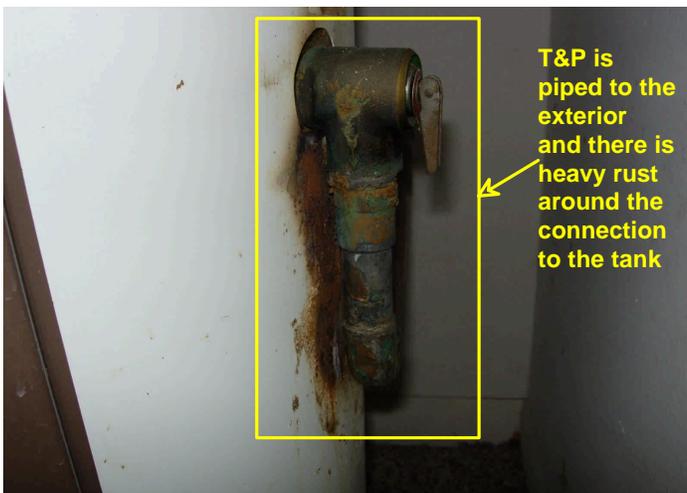
Pressure Release Valve and Discharge Pipe

- The temperature and pressure relief valve is not piped, per code the valve is to be piped to a safe location, which is usually interpreted as within 6" of the floor and preferably behind the tank, but it has to visibly discharge in the same room as the water heater is located. There is also heavy rust around where the T&P connects to the water heater.

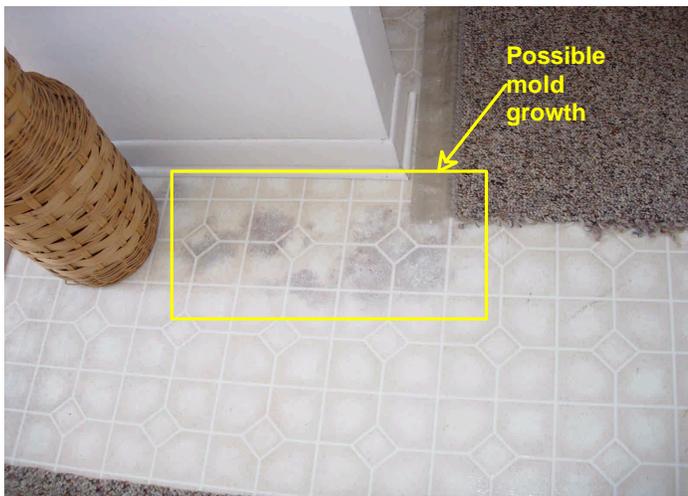
Floor

- The floor in the entry is vinyl. High levels of moisture were indicated and there appears to be mold growing underneath it.

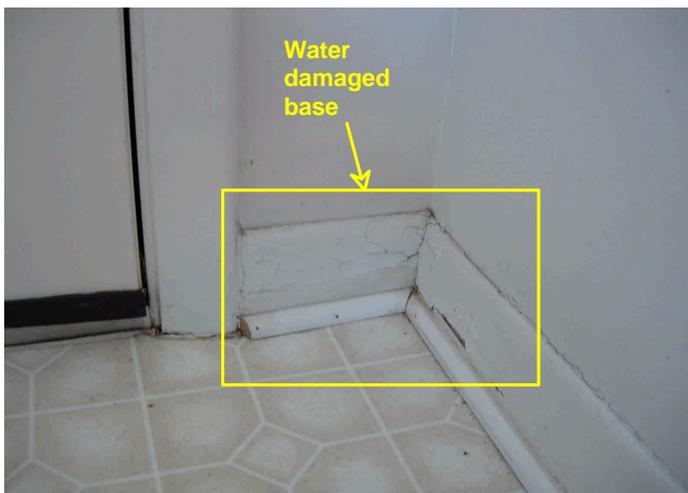
Walls and Ceiling

- There is evidence of moisture intrusion at the base board by the front entry door.

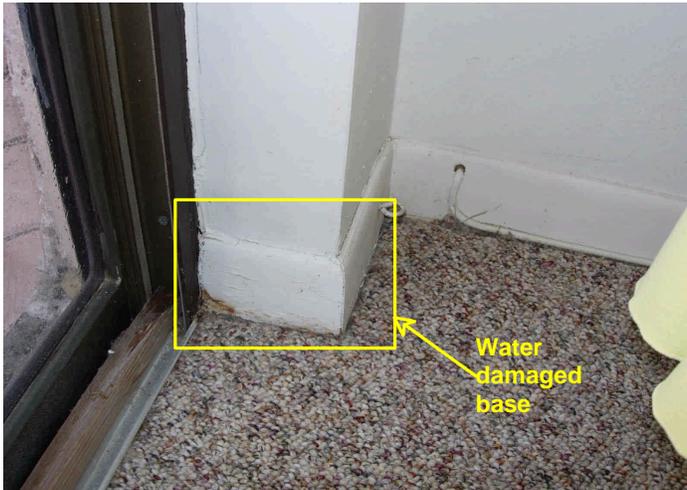
**Living
Doors**

- The Glass Sliding Door in the living room is functional but there is evidence of water intrusion as seen by the water damaged base board to the right of the doors.

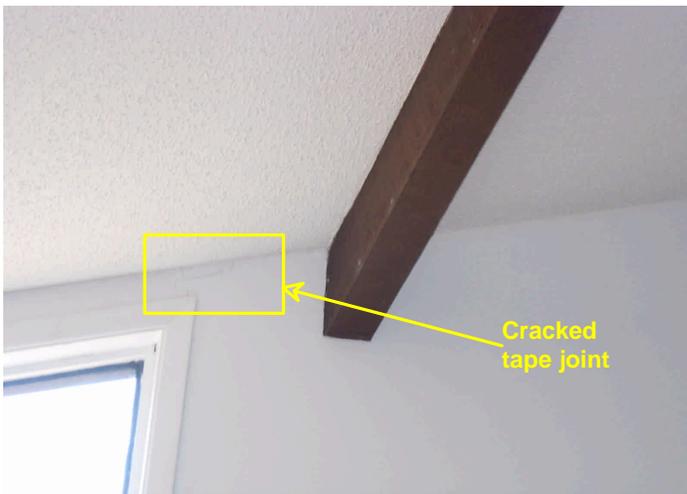
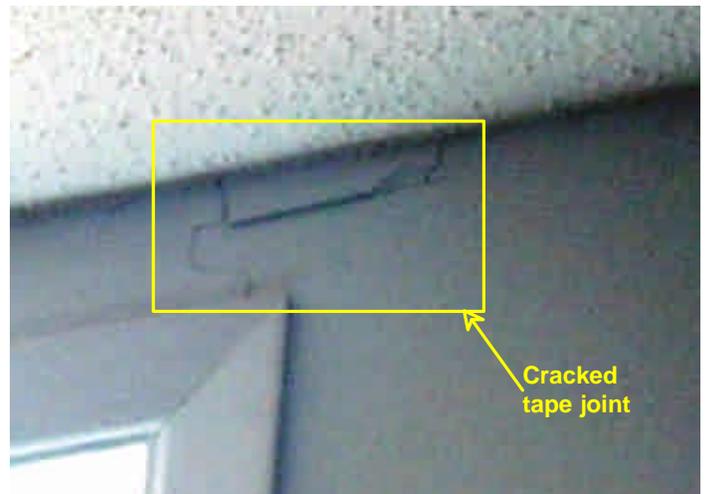
Walls and Ceiling

- There is evidence of possible moisture intrusion by the top of the fixed window as evidenced by the cracked drywall tape joint.

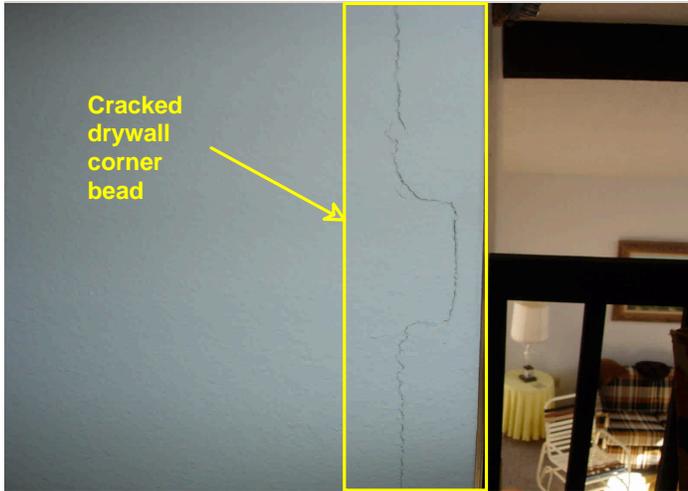
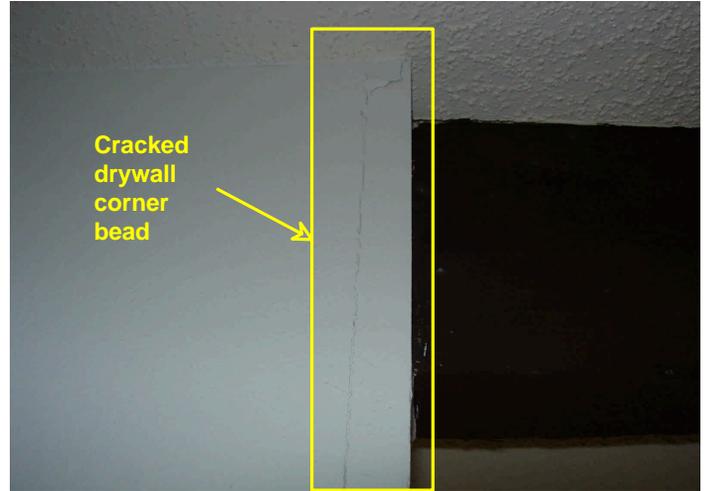
Walls & Ceiling

- There is a cracked drywall corner bead in the master bedroom, the cause of which is undetermined.

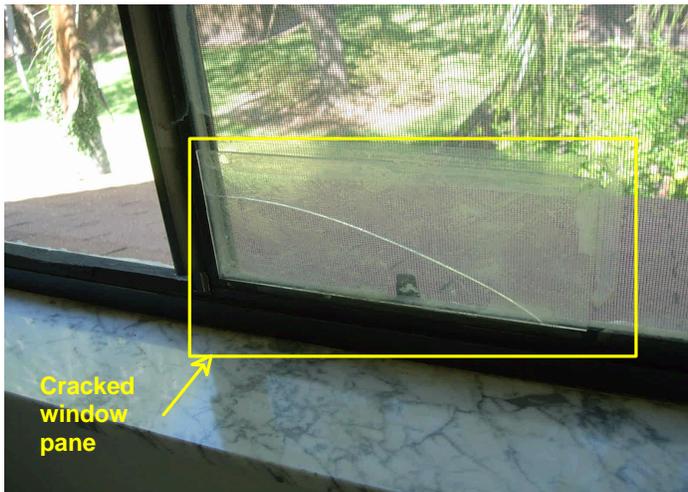
Single-Glazed Windows

- The bedroom window is cracked, and should be repaired.

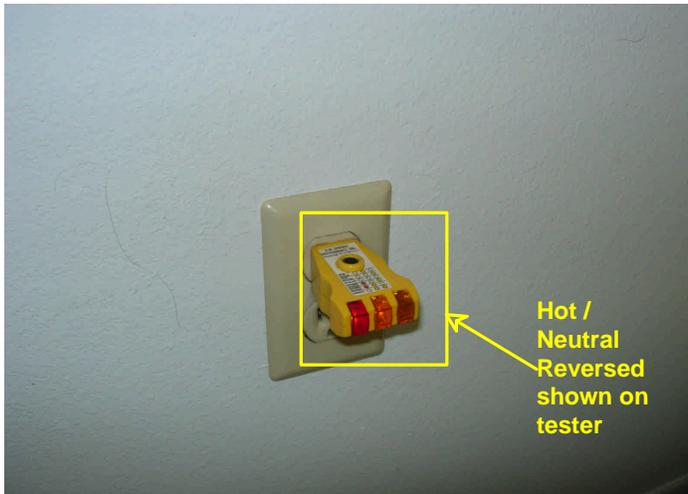
Outlets

- One of the bedroom outlets has reversed polarity, and should be serviced by an electrician.

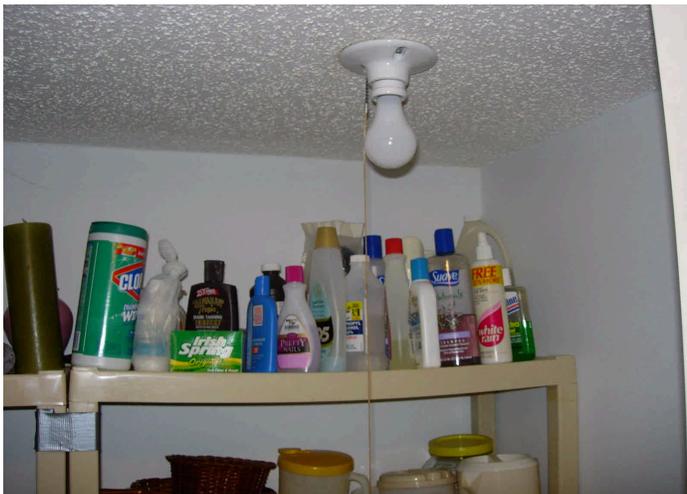
Closet

- The closet employs an incandescent light bulb that should have a cover. This style of light is a fire hazard in this type of location.

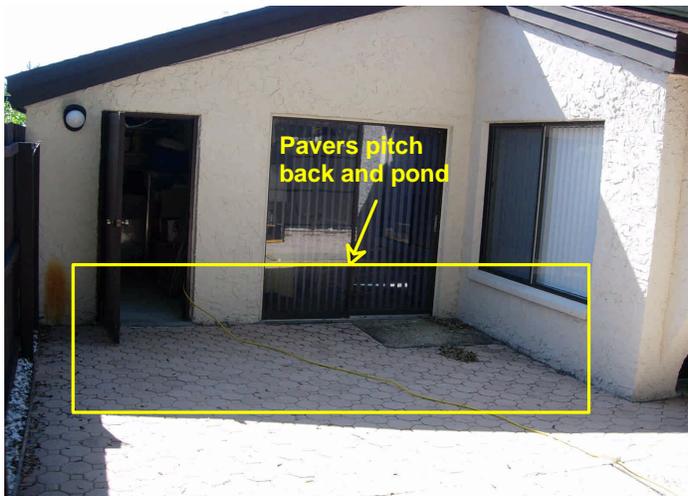
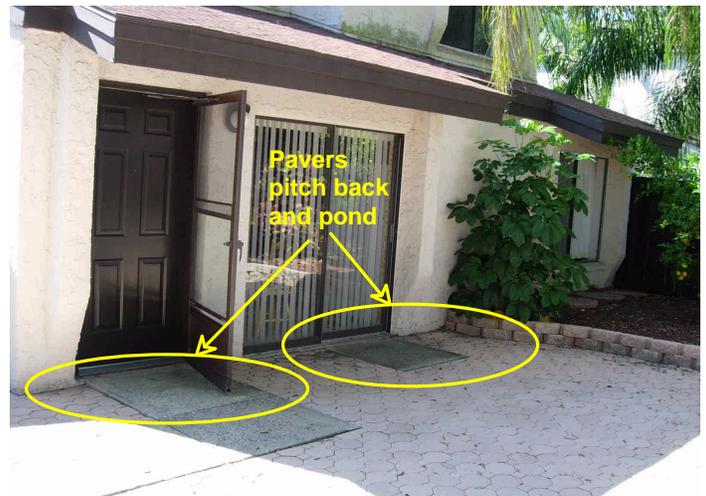
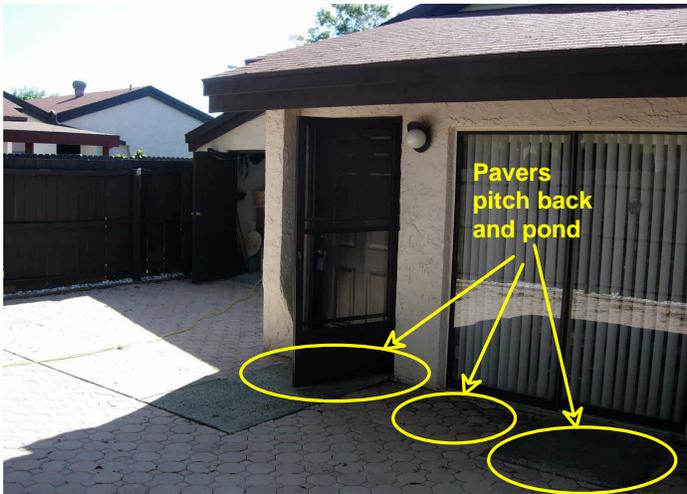
Pavers have been installed in the courtyard area, which does not allow for rainwater to percolate into the soil. Also, the exterior elevation is close to being the same as the interior elevation and the pavers drain towards the structure instead of away, both of which create moisture problems.

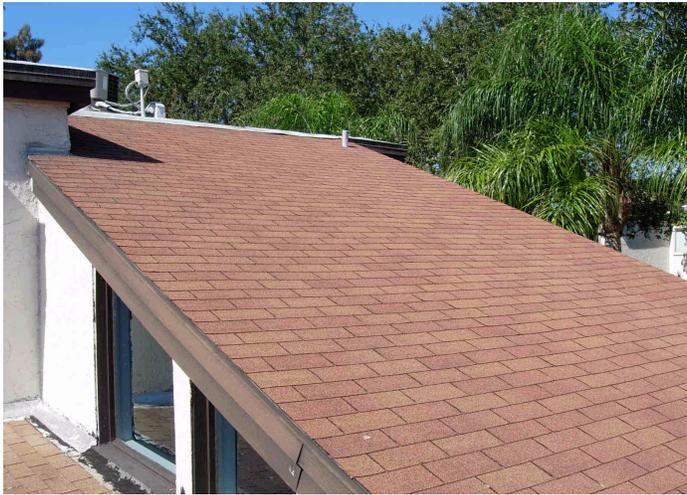
The composition shingle roof appears to be newer. This is just an estimate and you should request the installation permit from the sellers, which will reveal its exact age and any warranty or guarantee that might be applicable.

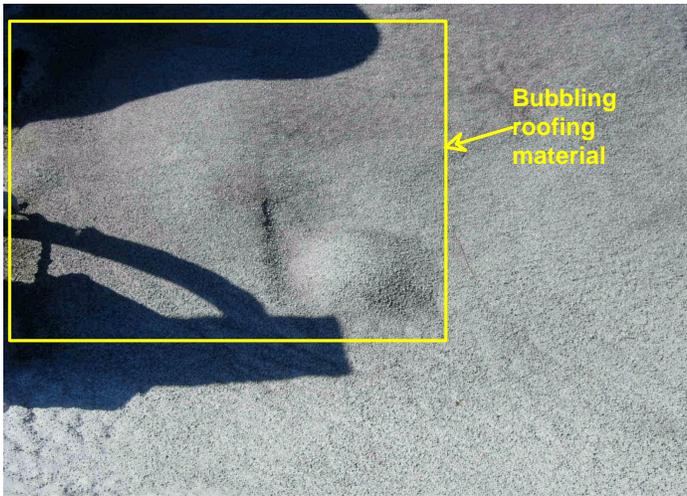
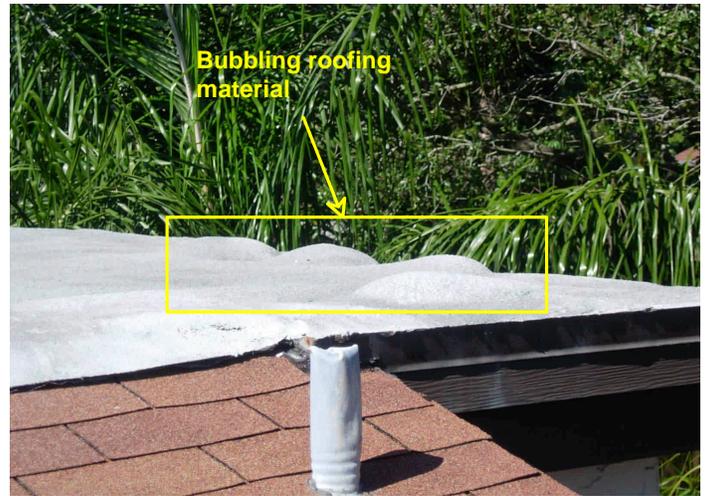
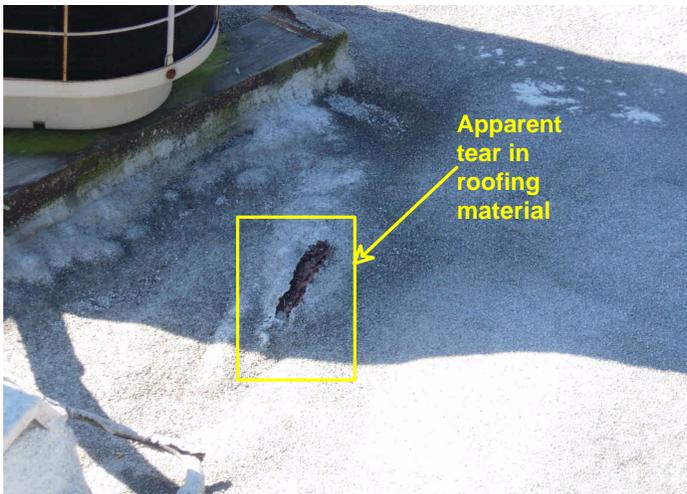
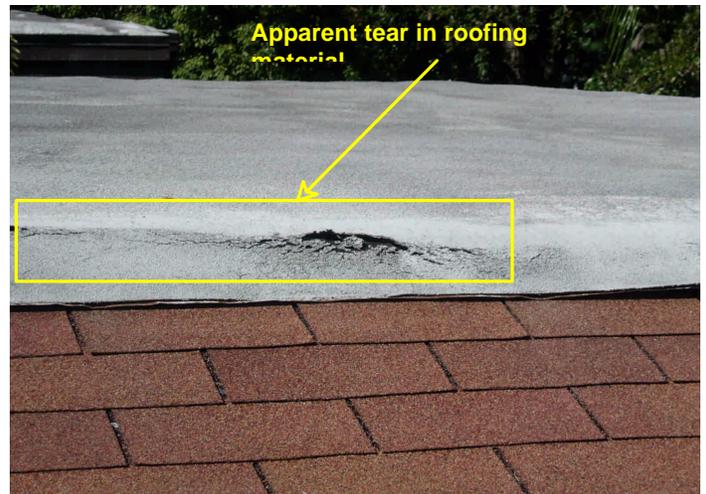
With Flat Roofed Sections

The roof appears to be insulated with a rubberized coating and there appears to be moisture in the insulation, causing the rubberized material to bubble. There also appears to be several tears in the top membrane that may allow moisture to penetrate the roof. This moisture can migrate into the living space, causing moisture problems inside the dwelling. Further investigation is warranted by a licensed roofing contractor.

We can elaborate on this issue, but it should be serviced before the close of escrow or it may leak, because our service does not include any guarantee against leaks.

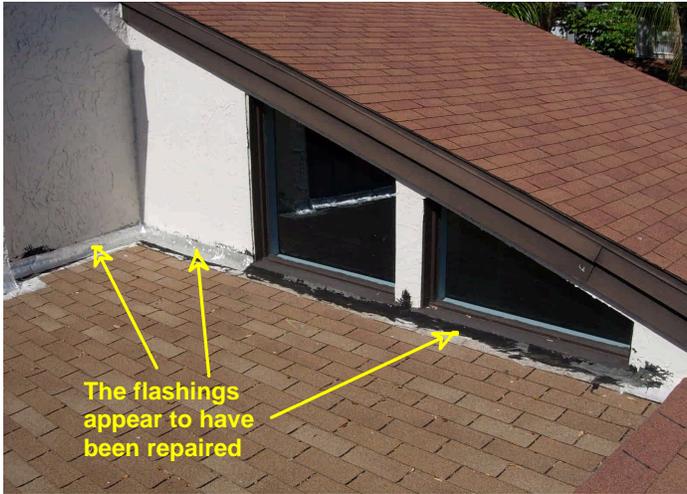
Flashings

The flashings appear to have been repaired but the quality of the repair is undetermined. These should also be inspected by a licensed roofing contractor.

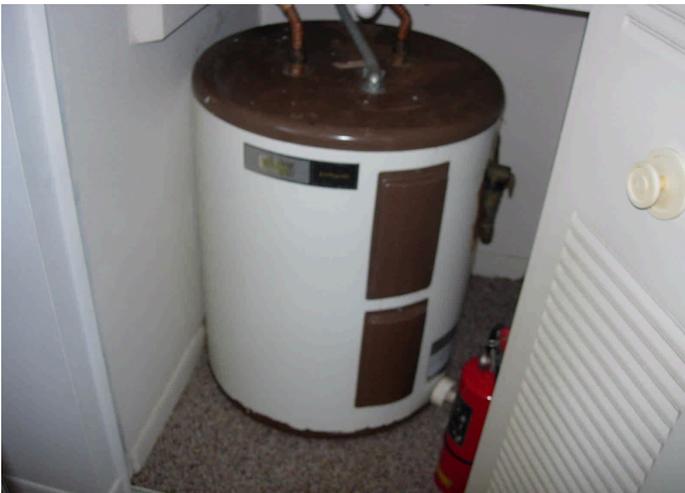
Hot water is provided by an apparently 25 year old, 30 gallon, electric water heater located in a the dining room closet.

The water heater is manufactured by White
Model #: Not Accessible
Serial #: Not Accessible

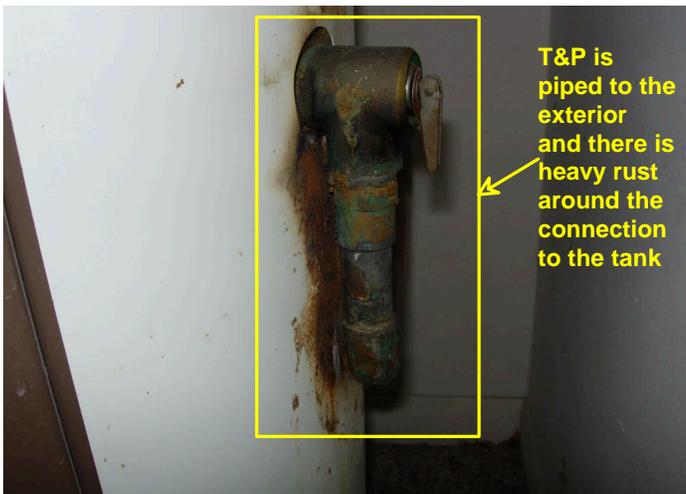
The temperature and pressure relief valve is not piped, per code the valve is to be piped to a safe location, which is usually interpreted as within 6" of the floor and preferably behind the tank, but it has to visibly discharge in the same room as the water heater is located. There is also heavy rust around where the T&P connects to the water heater.

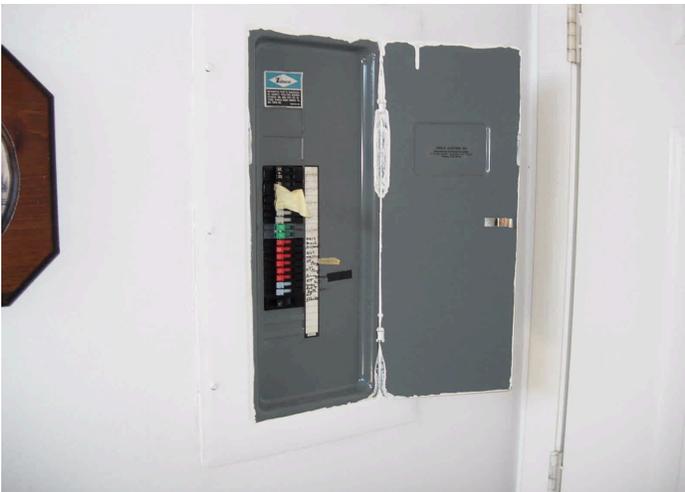
The residence is served by a 150 amp, 120/240 volt panel, located in the front entry.

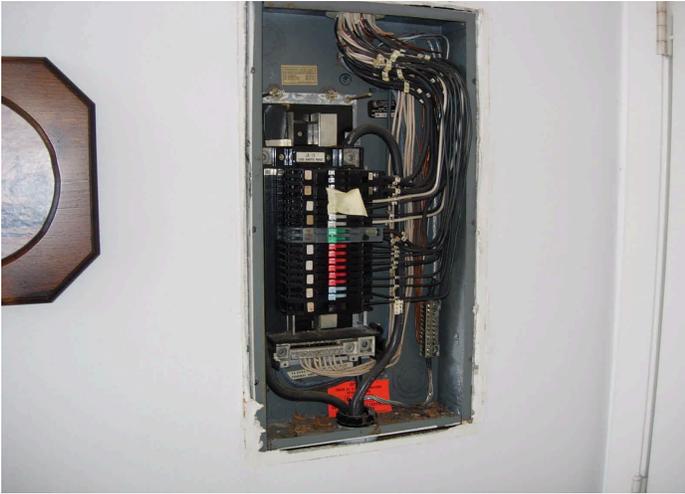
The main panel and its components have no visible deficiencies.

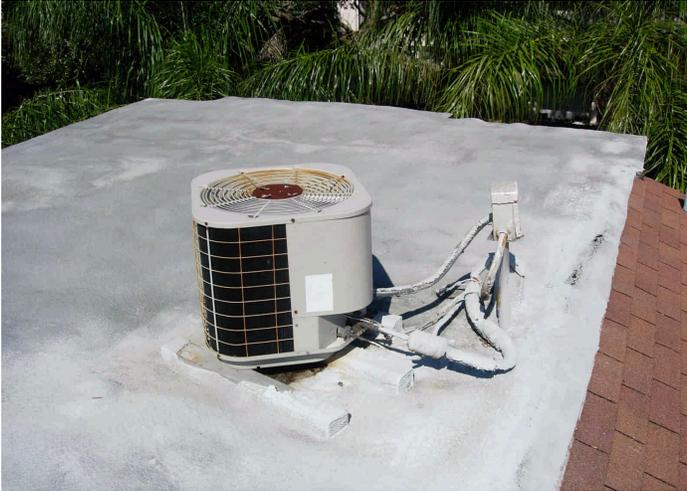
The condensing unit is a 2 1/2-ton Rheem Classic X Super High Efficiency. The unit appears to be within 5° of level. It is free from obstructions and sits approximately 1-2" above grade on a concrete slab. The liquid and suction lines are in good condition, free of twists and kinks. The insulation on the coolant line is in fair condition.

Model #: RAHE-030JAS

Serial #: 4008 M2092 0600 (manufactured the 20th week of 1992)

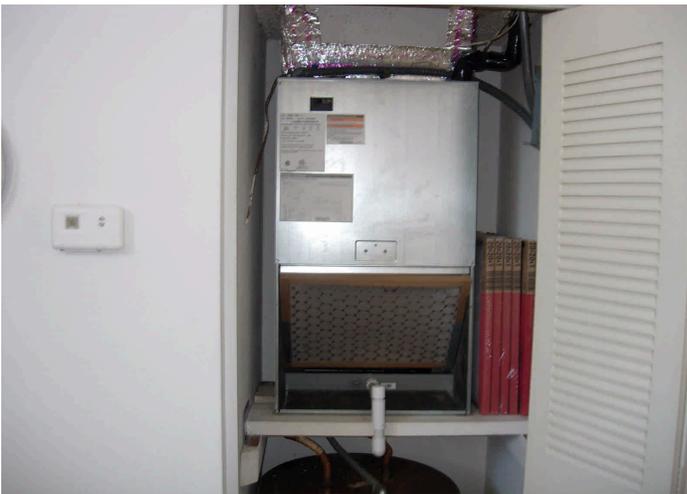
The air-handler is a Nordyne. The supply and return air temperatures were 63° and 73°, respectively. This gives a temperature differential of 10°, which is below the desired range of 14° to 22°, and well below the optimum range of 18° to 21°.
Model #: GB3BW-024K-10
Serial #: GBD040300025

The air-conditioning responded, but only achieved a low differential temperature split between the air entering the system and that coming out. This could indicate that the system is low on refrigerant, and should be serviced.

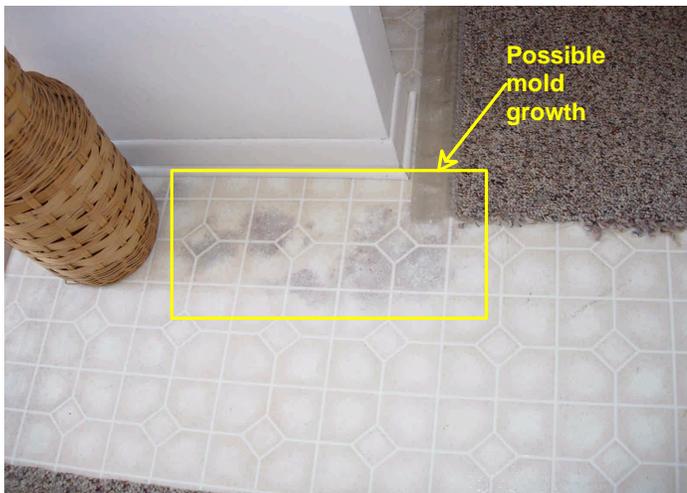
The floor in the entry is vinyl. High levels of moisture were indicated and there appears to be mold growing underneath it.

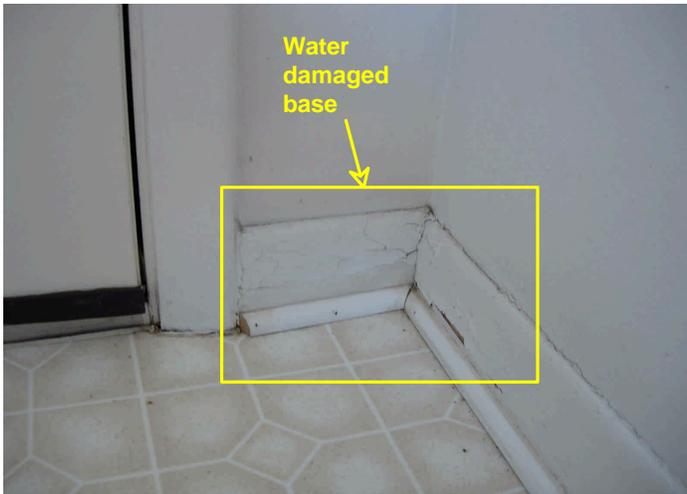
Walls and Ceiling

There is evidence of moisture intrusion at the base board by the front entry door.

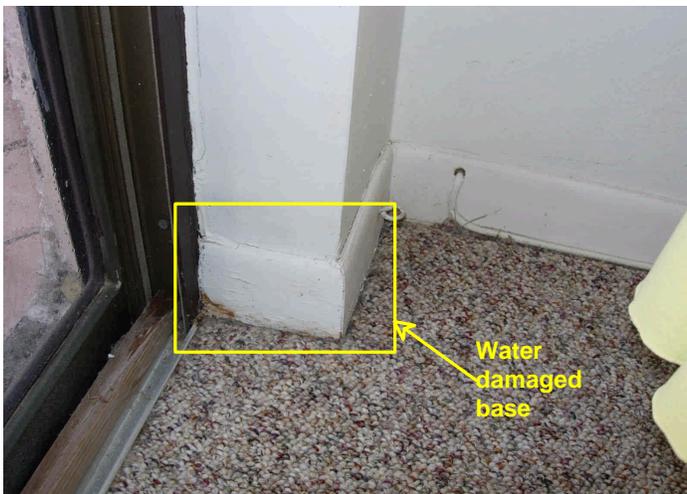
The Glass Sliding Door in the living room is functional but there is evidence of water intrusion as seen by the water damaged base board to the right of the doors.

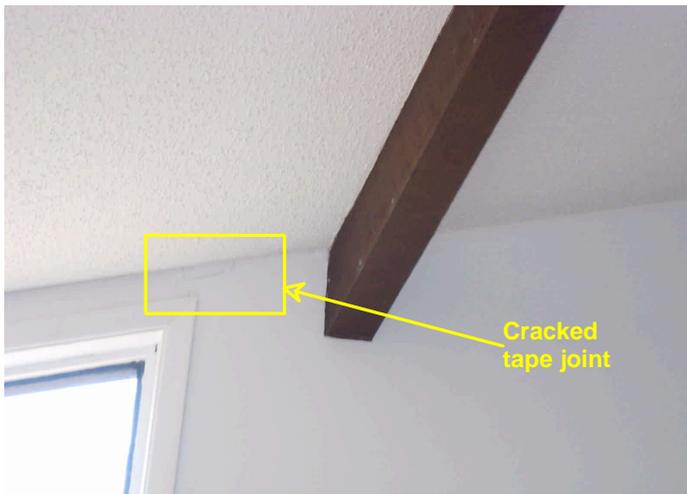
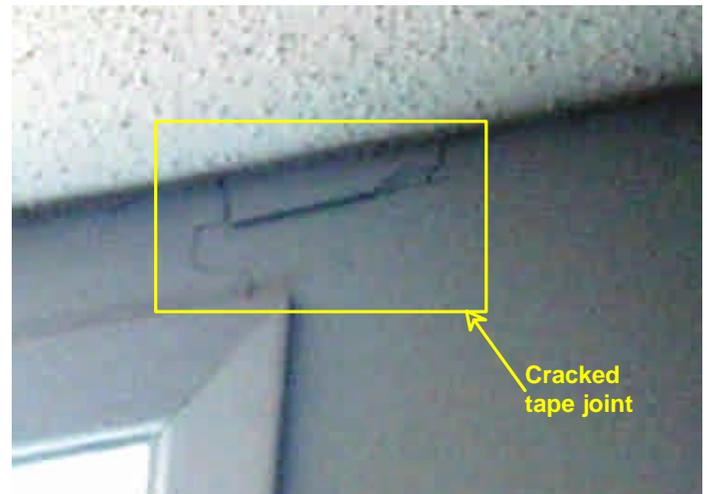
There is evidence of possible moisture intrusion by the top of the fixed window as evidenced by the cracked drywall tape joint.

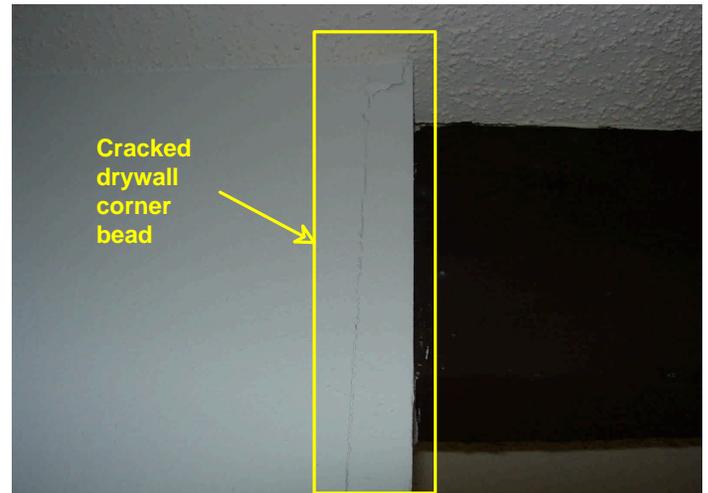
There is a cracked drywall bead in the master bedroom, the cause of which is undetermined.

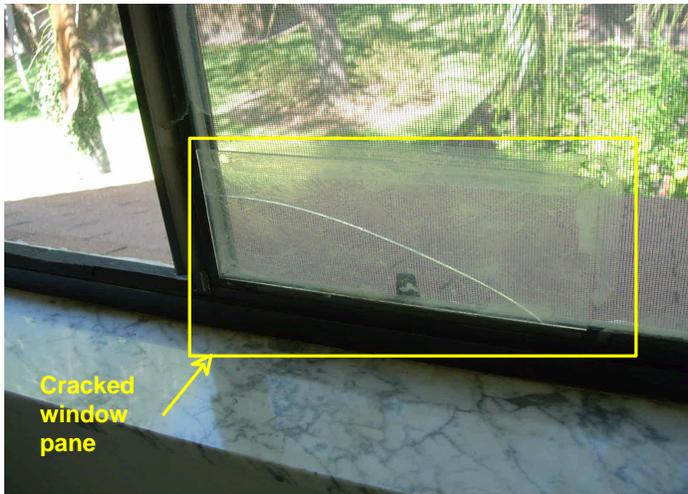
Single-Glazed Windows

The bedroom window is cracked, and should be repaired.

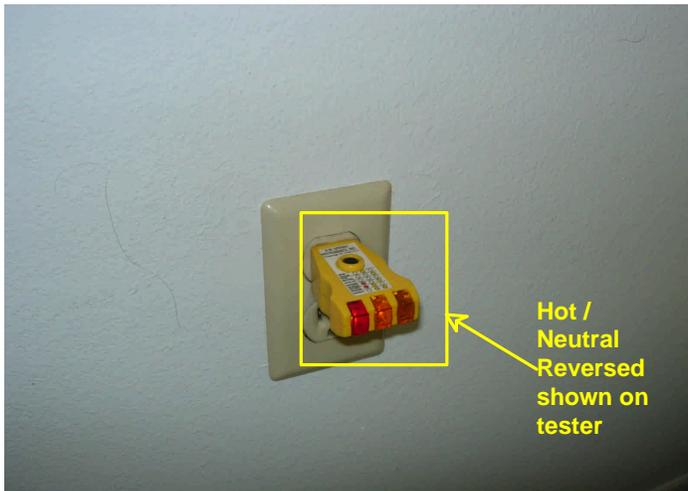
One of the bedroom outlets has reversed polarity, and should be serviced by an electrician.

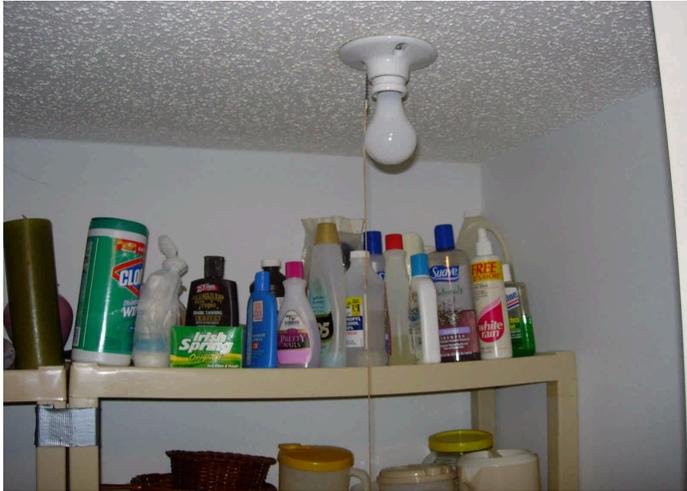
The closet employs an incandescent light bulb that should have a cover. This style of light is a fire hazard in this type of location.
